PRE-STRESSED STEEL CABLES AND BARS IN CONSOLIDATION OF MONUMENTAL BUILDINGS

LORENZO JURINA

Politecnico di Milano – Dept. of Structural Engineering
Piazza L.da Vinci 32, 20133 Milano, Italy

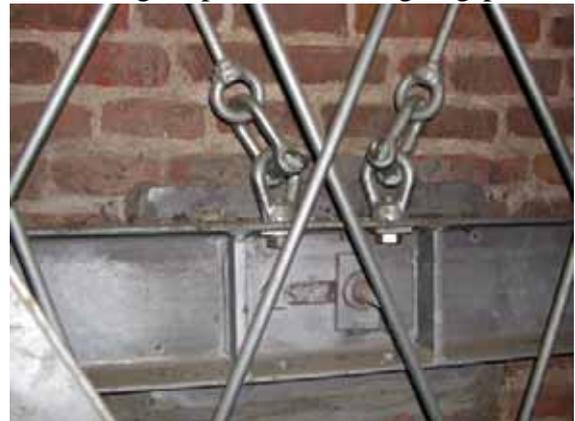
San Dalmazio Tower, Pavia (Italy)

This 45 meters high, XI century, brick tower showed many local damages and lacks in the masonry and long vertical cracks along the four walls. The strengthening project involved construction of a new inner metal tower made partly of carbon steel and partly of stainless steel, which is fully exposed and completely renewable but entirely located inside the tower so that it could not be noticed from outside but for of a number of discrete signals declaring its presence; in other words, a “**tower within a tower**”.

The dead load of the masonry is partially transferred to the inner tower by means of about 300 prestressed **sub-vertical cables**, laying in the interstice between the masonry and the steel tower. The new structure takes into account the culture of preservation, such as adoption of strengthening work which stands

and finishes, which are where structural decay often starts. In the strengthening project on the masonry tower, additional stainless components were used to create **radial tie bars** that pass through regularly spaced horizontal holes just existing in the masonry. The aim is to “*confine*” laterally the walls adding horizontal loads, thus connecting the various vertical layers of the masonry. As seen, the more expensive stainless steel material is used in the areas which are most exposed to the air and most closely in contact with the old masonry.

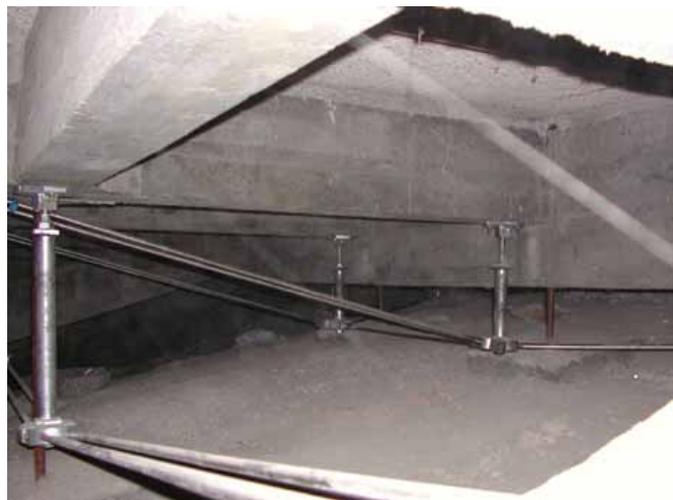
Visconteo Caste, Pavia (Italy)

The Visconti's XV century castle in Pavia has suffered the vicissitudes of time and now has only three remaining sides and two corner towers, which have been subjected to repeated restoration and modification. In the early XX century the Southwest Tower was in very poor conditions, with fissures and depressions in the large vault on the first floor, so that in 1925 the flooring and the filling material was completely removed. A new reinforced concrete floor was constructed above the vault, rigidified with rib beams, to provide support for live loads. For greater prudence (as it seemed at the time) the masonry vault was *suspended* from the reinforced concrete floor using twenty metal rods, 30 mm in diameter. In 1995 the concrete floor, which had been left exposed for many years, was paved. Only a few months later the pavement unexpectedly lifted and cracked visibly. The diagnosis was *viscous yielding* of the reinforced concrete floor subject to a considerable permanent load. The floor lowered and required the pavement itself to take on a structural role, subjecting it to compressive stress that led to a buckling phenomenon. This theory was confirmed by inspection of the hollow between the vault and the floor, which revealed that some of the 20 metal "safety" tie bars had buckled due to compressive stress, so that a part of the reinforced concrete floor was resting on the vault below it. The first action taken was a modification of the connection that permitted them to act as tie bars only, not as struts. The concrete in which they were embedded at the top was in fact removed to leave them free to slide vertically only in one direction.

The problem that remained was construction of a new structure alongside the existing floor to minimise any further yielding, taking into account the fact that only 27 cm existed between

the vault and the floor at the crown, which did not permit new structures of sufficient structural height to be introduced. As is often the case, the solution lay in finding a "way around" the difficulty. An "*octagonal ring*" about 500 cm in diameter was created out of stainless steel bars and a set-up of bars and struts all within the space between the extrados of the vault and the horizontal floor. The ring, positioned concentric to the vault but 60 cm below the height of the crown, became the point at which eight pairs of diagonal tie rods coming from the upper edges of the lattice converged. The ring therefore serves to ensure the structural continuity of the tie bars, going around the top of the vault while permitting the correct structural height to be achieved. The cables are subjected to uniform traction controlled by adjusting the eight stainless steel struts. A large screw at the end can be used to lengthen and buck the struts, constrained by the reinforced concrete floor above.

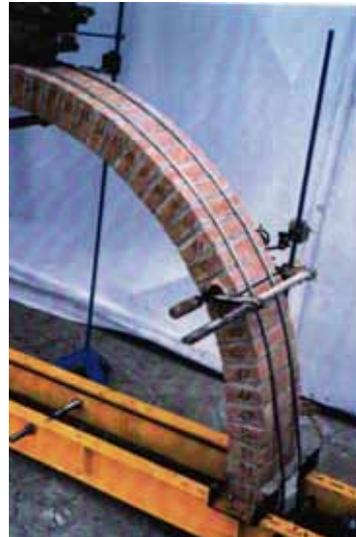
The vaults of the Medici Castle in Melegnano (Italy)

After some experimental tests, a special technique was suggested by the author to increase the load-bearing capacity and safety of the vaults, in which a series of stainless steel cables parallel to the extrados are used, in a technique referred to as the “reinforced arch method”.

These cables are connected to the masonry to the side by means of a system of threaded bars, thimbles, fasteners, and eyebolts, all made of stainless steel, and put under traction by a system of screw couplings. The vault is thus subjected to radial loads which increase its compression, improving its resistance to pressure-flexure induced by incidental loads, especially asymmetrical loads. The technique achieves a result equivalent to or in some cases better than that obtainable with the traditional covering of the vault from above with a layer of collaborative reinforced concrete. In this way the additional structure does not interfere with the material and structural reality of the existing building and is invasive only to a limited extent. Stainless steel's versatility, strength and durability make this a lightweight, reversible,

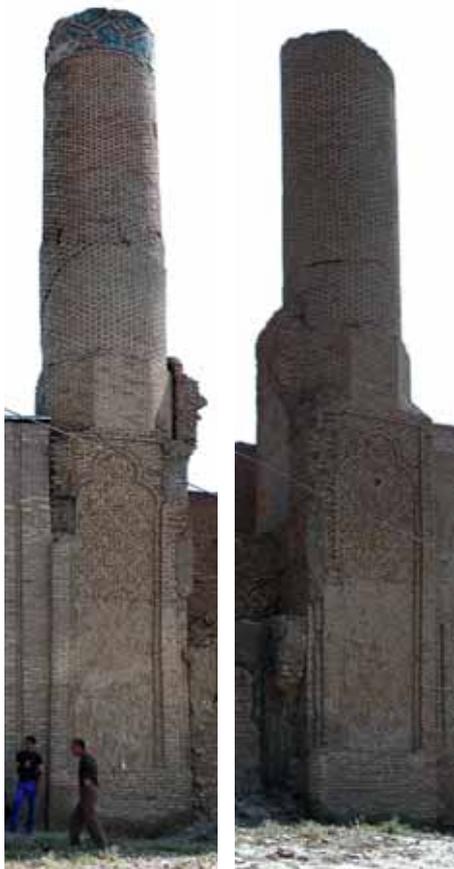
FEM- Finite Element model of the minaret
Horizontal stresses and induced cracks along the stairs

Traction stresses and consequent cracks in the tallest minaret

As for **the taller minaret**, the first task was to investigate the kinematical action underway in an attempt to provide a quantitative description of the phenomenon of expulsion of part of the masonry in the lower half of the minaret. It is clear that earthquake stress was severe in the circular-section lower part. The additional presence of two factors – a big window that interrupts the continuity of the walls and a spiral staircase that gave raise to a substantial structural eccentricity – caused a sideways slippage of the minaret, which at the same time rotated in a clockwise direction. The photographs clearly show the spiral dislocation of the bricks, visible both inside and outside, immediately above and below the section held in place by the bricks of the staircase. In other words, *the spiral staircase very probably acted simultaneously as a local reinforcement agent and*

as an element of global asymmetry; the combined effect was cracking due to rotation-translation motion. The zones of masonry immediately above and below the spiral staircase show signs of severe concentrations of tension that could have caused the masonry to break.

Numerical analyses have highlighted, also here, a marked torsion affecting this minaret. On the basis of the data currently available, we have noted a fairly good correspondence between the pattern of cracks visible on the monument and the areas subject to the greatest stress according to the
