**NEW TECHNOLOGY FOR THE PRESERVATION OF HISTORICAL BUILDINGS:
CASE STUDY OF THE MAGNIFICA COMUNITÀ PALACE AT CAVALESE
(TRENTINO – ITALY)**

This paper deals with a case study: the restoration of the Palace of the Magnifica Comunità di Fiemme, an autonomous board collecting the inhabitants of the Fiemme Valley in the Trentino Region (Italy). The restoration plan regards the changing of the inner spaces organization and, in particular, the structural reinforcement of the wooden floors, whose intervention plan has been the most complex but in the meantime the most interesting and innovative. The floors of the Magnifica Comunità Palace, in fact, are made of wooden elements frames finished with planks (both adorned with beautiful paintings) whose bending and torsional strength is limited. In order to make the floor elements bearing the required heavier loads, the structural intervention of reinforcements has been planned so to assure also the safeguard of the historical-artistic values of the building. Different solutions have been adopted for each floor, using innovative technologies as the plugging of a new kind of connector inside the wooden elements without resins, the reinforcemen

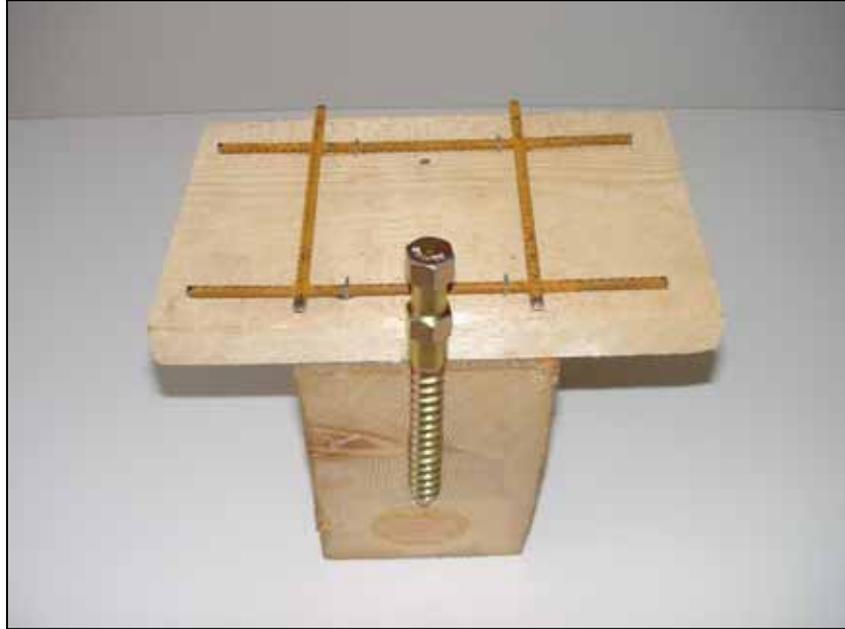
FIG.1: The particular steel pin screwed inside the wooden joists

Generally, and where possible, the realization of a stiff membrane is made by laying a concrete slab 5 centimetres thick on the upper plank of the wooden floor, and connecting them by means of steel pins plunged into the joists with a hooked-shaped connection to the slab reinforcement. This methodology is not really new, but here an innovative variation has been applied. In fact, the steel pins are generally connected to the wooden elements by means of injections of epoxidic resins into the housing hole. In this case, since many joists of the Magnifica Palace are painted and finely worked, and in order to avoid, in the next future, that the resin could percolate outside ruining the paintings, an innovative technique has been applied, screwing the pins into the elements without using resins or auxiliary glues. An effective connection between the steel element and the wooden one is guarantee by the particular thread of the former (FIG.1).

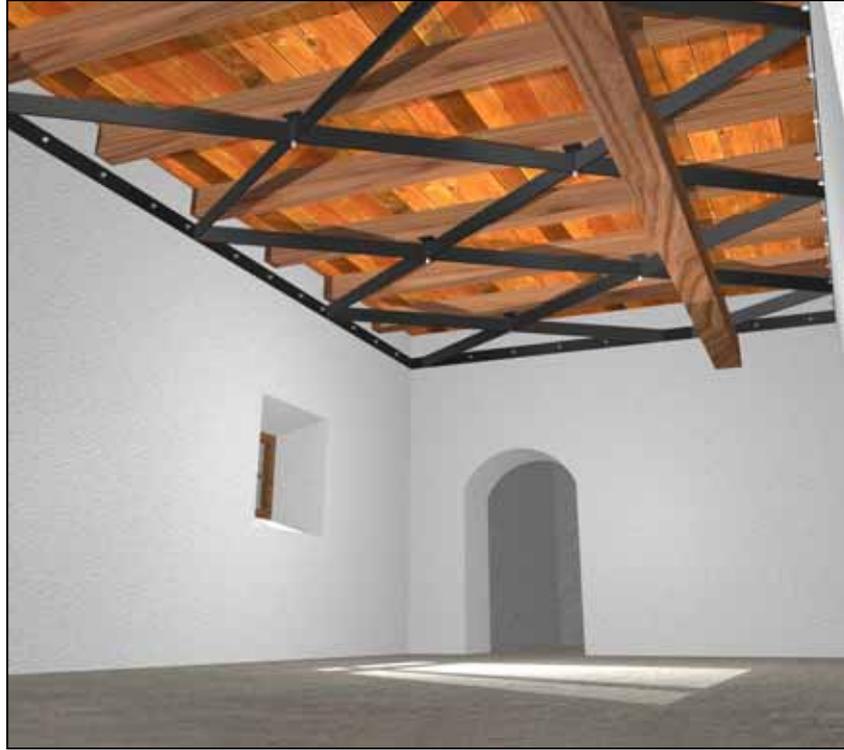
FIG.2: The spatial steel structure under the first floor

The engineers decided to realize a spatial steel structure under the floor, made of steel plates soldered together and connected to the outer walls (FIG.2). The plates have a constant step and a diagonal development comparing to the secondary frame, so that a lozenge-shaped plan is formed, whose vertices are the intermediate bearings of the joists. In this way, the joists have no more one but two spans, and the middle bending moment value decreases.

The steel structure has been dimensioned in order to be sufficiently stiff, to connect the outer walls and to bear the horizontal forces due to the earthquake.

The intervention is clearly visible, it is not hidden, it shows its presence in a floor that now has a wooden frame laying on a stiff steel structure, collaborating together to guarantee the structural safety. In this way, the original structure and the ancient Palladian floor are preserved, and the floor maintains its former shape and function.
