# **PROGRESS AND PERCEPTION OF SEISMIC STRENGTHENING IN A STONE MASONRY VILLAGE**

C. Chesi<sup>1</sup>, L. Jurina<sup>2</sup> and M. A. Parisi<sup>2</sup>

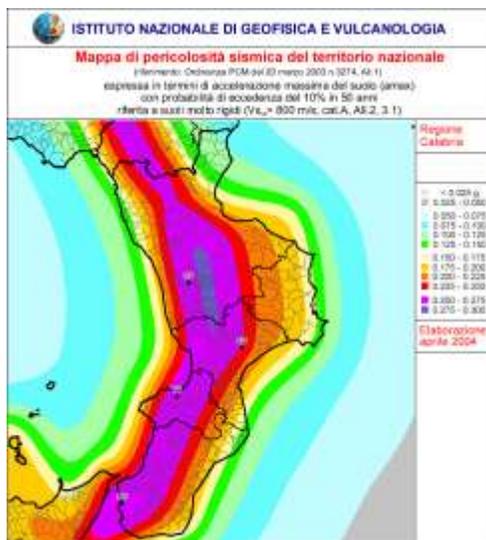
Figure 1. The hazard map for Region Calabria. Laino is located in the upper part of the Region, at the border between zones with expected peak ground acceleration of 0.225-0.250g and 0.250-0.275g.

The seismic hazard map produced by INGV, the Italian National Institute for Geophysics and

Vulcanology (figure 2), that has a finer resolution, specifies a peak ground acceleration of 0.250-0.275 g for the reference return period (475 years), confirming the attribution of Laino to the upper border of the second category, that is a medium-high seismicity.

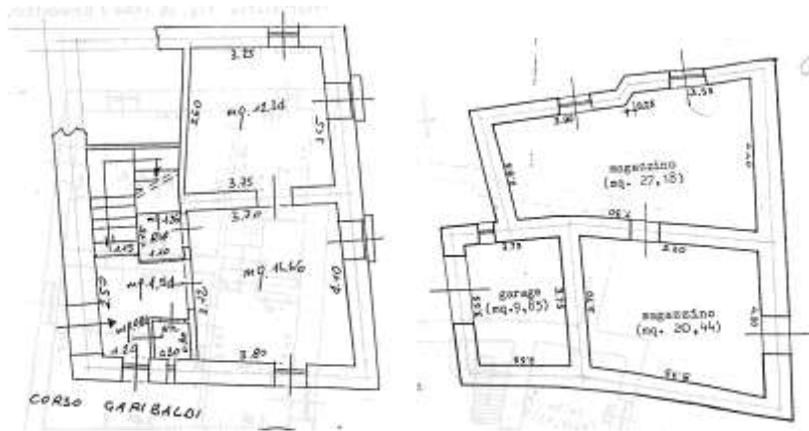
Figure 3. Two typical plan layout of the buildings of Laino, at ground level; shapes are often simple and compact.

The buildings were chosen in order to represent different layouts that are recurring in the village: a compact, almost square plan and rectangular plans with different aspect ratios; one of the buildings considered had an almost square but very large plan layout. Figures 3 and 4 show typical plans and the front view of a building.

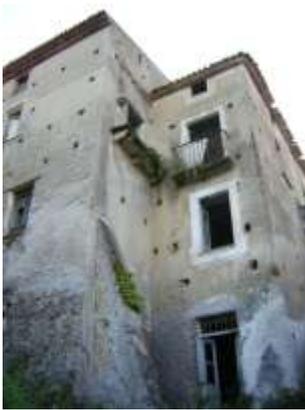
Figure 4. View of a typical building
